# Lake Tahoe Basin Management Unit Riverine Restoration Program

2003—2014

An overview of ecosystem benefits achieved and  
lessons learned

March 2015

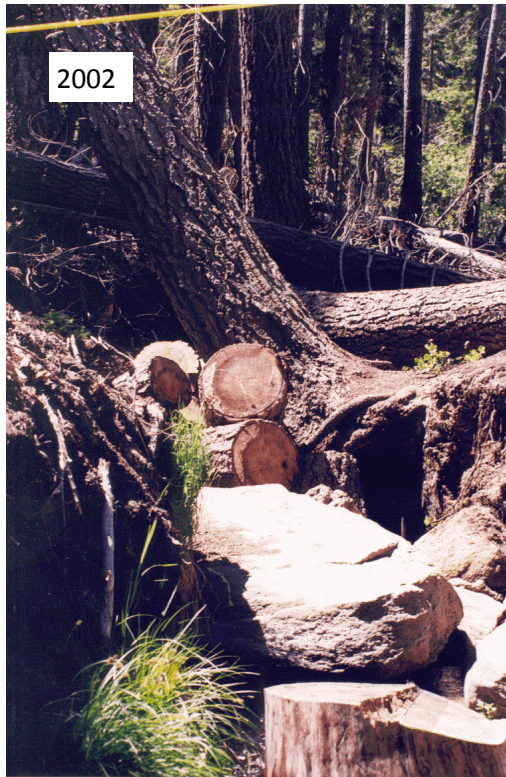
***Lonely Gulch Creek Prior to Restoration***

Lonely Gulch Creek is a west shore tributary of Lake Tahoe. The contributing watershed area above the project is approximately 3mi<sup>2</sup>. It is a high gradient forested stream bordered by a narrow willow-alder dominated riparian corridor. Common stream bed forms are step pools, high gradient riffles, and cascades. This type of channel is characteristically stable; however this pre project 2002 photo shows the combined effects of an unnaturally dense forest, and channel banks destabilized by the record January 1997 flood.

Restoration completed in 2003 was designed to arrest accelerated channel erosion in a 400 foot reach. The goal of site stabilization was to provide the structural foundation to support stream riparian vegetation recovery.

Treatments involved stream bank reshaping, strategic placement of stream bed and bank protection utilizing logs and boulders collected on-site, and planting willow and alder shrubs to initiate riparian vegetation recovery.

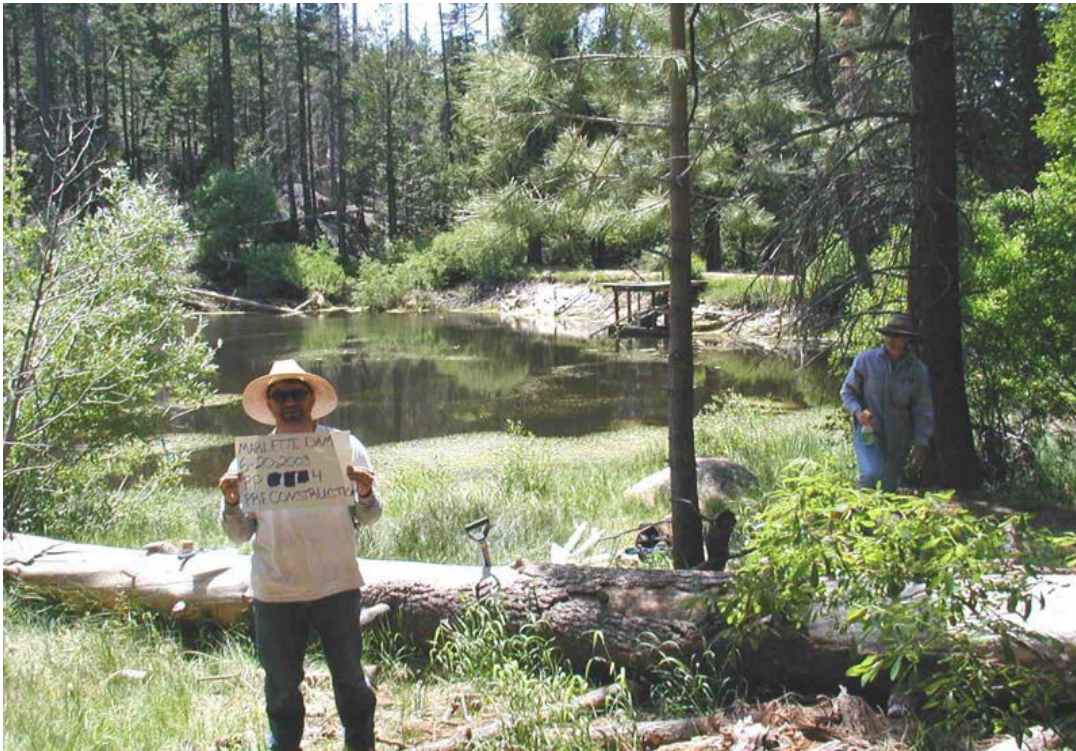
Marlette Dam was an un-maintained earthen dam with a large gully below the dam's spillway caused by past storm events. The gully eroded approximately 200 cubic yards of soil from one side of the valley, undermining the riparian forest and lowering the base level of the original stream channel. In addition, the reach 50 feet directly upstream from the inlet to the reservoir was experiencing active bank erosion and there was a large depositional zone where the stream dropped its sediment load as it flowed into the reservoir.

***Marlette Dam and Reservoir prior to restoration.***

The Marlette Creek Dam Removal and Restoration Project was implemented in August of 2003, and involved the removal of the earthen dam and reconstruction of the stream channel for approximately 200 feet through the reservoir site created by the dam.

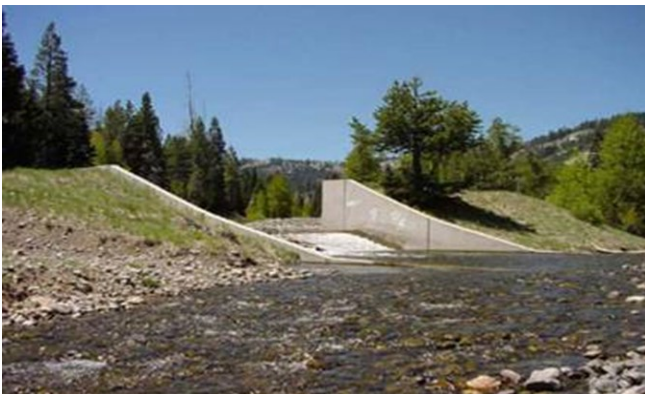
***Blackwood creek fish ladder prior to removal***

Between 2003 and 2006, the U.S. Forest Service removed the concrete fish ladder and replaced a large culvert with a bridge, including reconstruction of adjacent stream channels at both sites. These features were replaced with a series of constructed boulder step pools to maintain a stable stream profile, while restoring function in terms of coarse bed load sediment transport and fish passage.

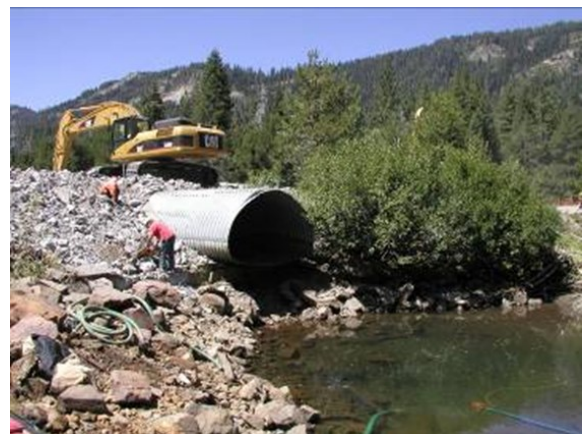
***Blackwood Creek culvert prior to removal***

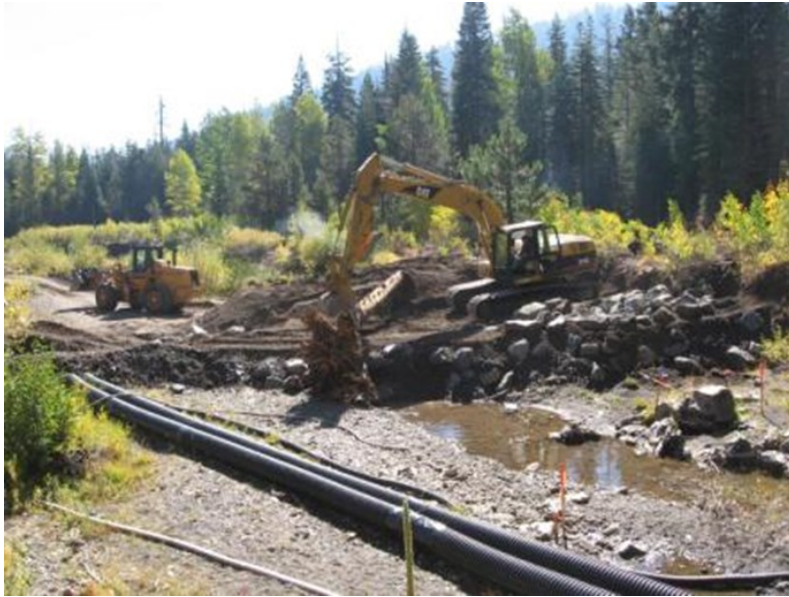
*Construction of rock/log flow deflection structure in Blackwood Creek*

In 2010 and 2012, the USFS reconstructed stream channels and floodplain morphology to restore flow dynamics within another 4,000 foot reach of Blackwood Creek and hydrologic connectivity to 35 acres of adjacent floodplain. Restoration actions consisted of constructing boulder grade control weirs and sills and importing river alluvium to raise the river bed 3 feet in elevation, re-shaping stream channels and associated floodplain, and installation of wood debris/bank protection structures.

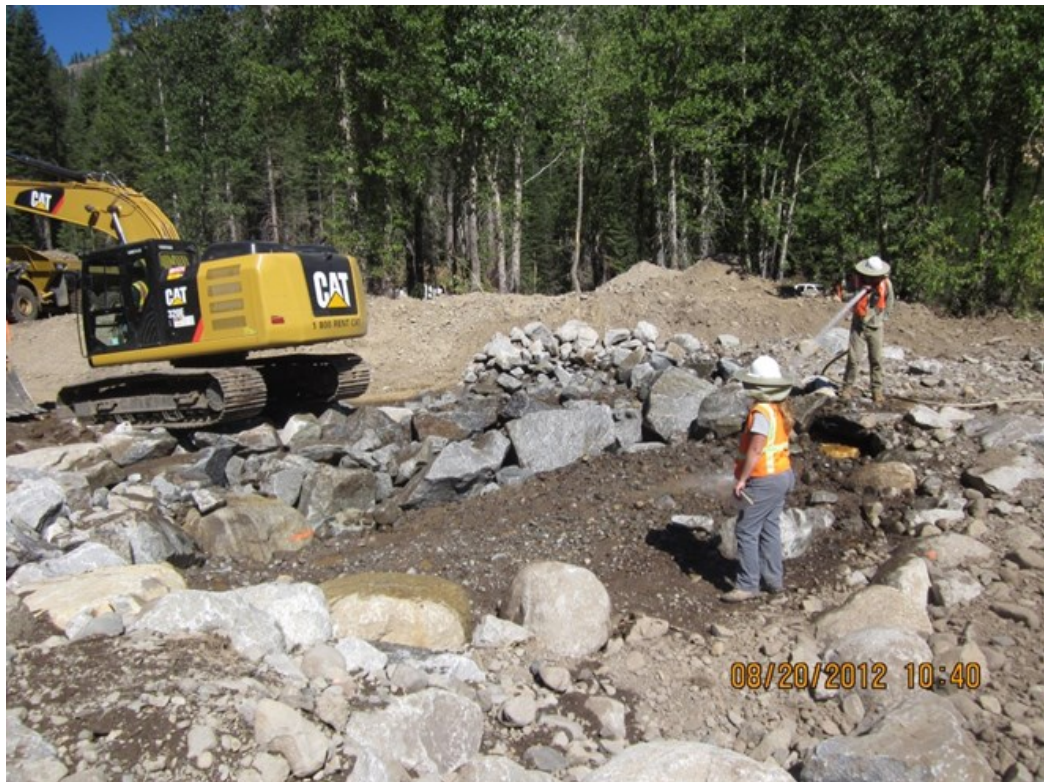
*Construction of boulder grade control weir in Blackwood Creek*

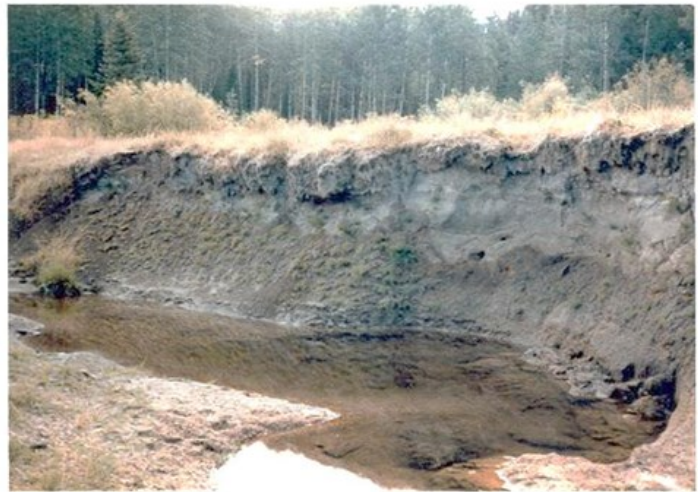
The existing Big Meadow creek channel through Cookhouse meadow, incised 8 feet over a period of 30 years, as a result of the installation of a highway culvert and over grazing (illustrated in the photo to the right, taken in 1981). This channel incision resulted in lowering the ground water table, preventing overbank flows from flooding out into the meadow resulting in a conversion to dry site meadow vegetation and degraded riparian habitat.

*Big Meadow creek prior to restoration*

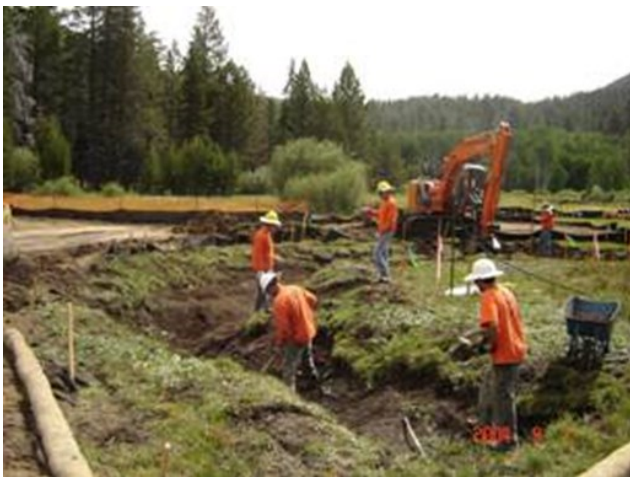
*Placement of salvaged sod on newly constructed stream banks at Cookhouse*

In 2005 and 2006, the USFS constructed 2,400 feet of new channel and obliterated 1,400 feet of existing deeply incised and eroding stream channel. This was the first project implemented by the LTBMU in which it was possible to salvage and harvest native vegetation at a large scale to quickly create stable channel bank and floodplain surfaces immediately post construction. This was also the first large scale project constructed by the LTBMU utilizing only USFS staff. This significantly reduced cost, and allowed greater flexibility in implementing “field fits” when unexpected site conditions were identified during construction.

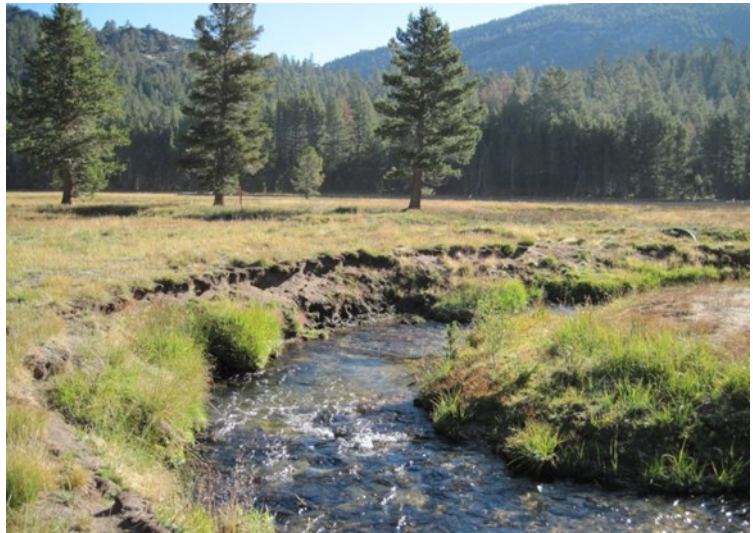
The Forest Service acquired 1,790 acres of land in January 2003 located in the upper Cold Creek Watershed, including a 200-acre montane meadow complex known as High Meadows. This landscape was highly altered and degraded since the mid-nineteenth century by logging, and over 100 years of cattle grazing and associated diversion ditches. Like Cookhouse Meadow, this led to down cutting and widening of the stream channel, resulting in a lowered groundwater table, drying out of the meadow vegetation and lodgepole pine encroachment (illustrated in photo to right taken in 2004).

***Cold creek prior to restoration***

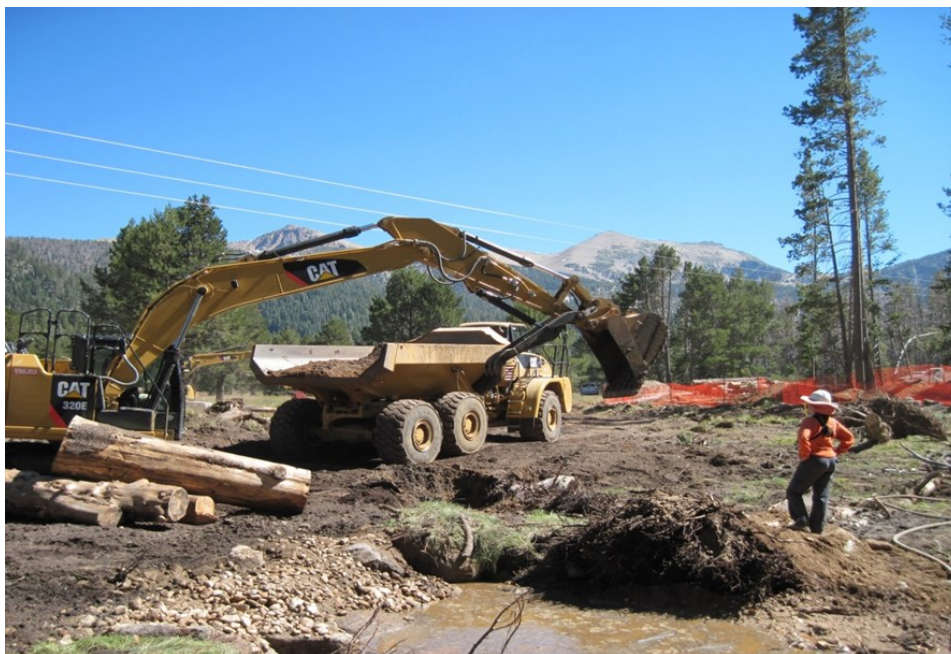
***New channel construction at Cold Creek***

Restoration actions were similar to Cookhouse Meadow, with abandonment of the existing channels to be replaced with 3,600 feet of new channel. In addition 1,500 feet of one of the tributaries to the main channel was restored through the placement of wood debris structures. Approximately 1/3 of the wood structures were installed by equipment and the rest installed by hand. Eight acres of dead lodgepole pine that had recently suffered mortality from a large scale bark beetle infestation was removed from the meadow boundary. This project used similar sod harvest and salvage techniques utilized at Cookhouse meadow, and again was implemented completely by USFS staff. Because of the remote location of this site all rock/gravel substrate used in constructing restored stream channels was harvested on site.

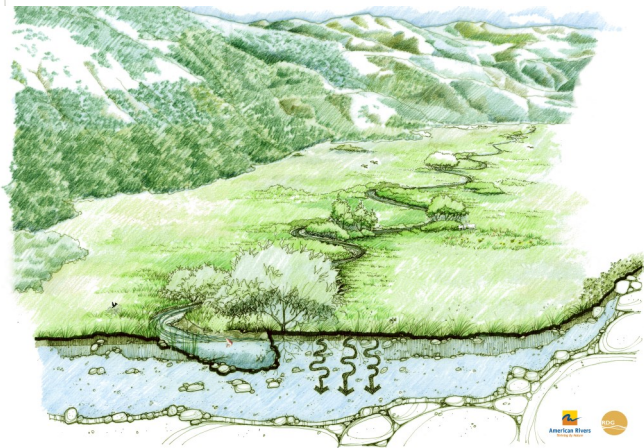
The two diagrams below provide a visual illustration of the desired outcome from riverine restoration efforts in meadow systems.

***Riverine restoration in meadow systems, replacing unstable, incised streams with poor habitat (left) with resilient stream channels that provide high quality habitat, and restored natural water storage and treatment capacity (below).***

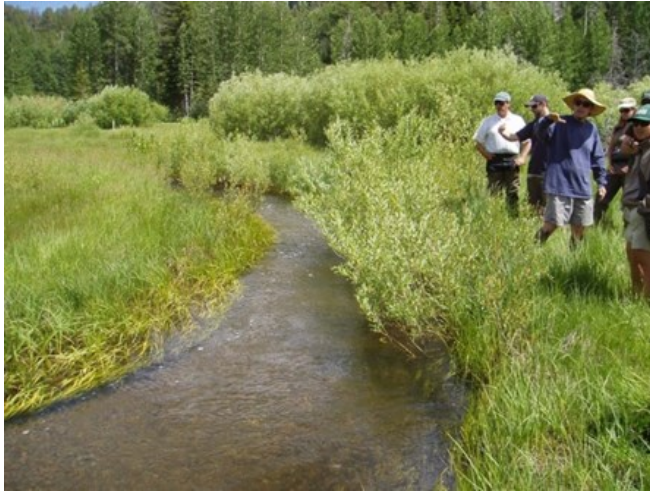
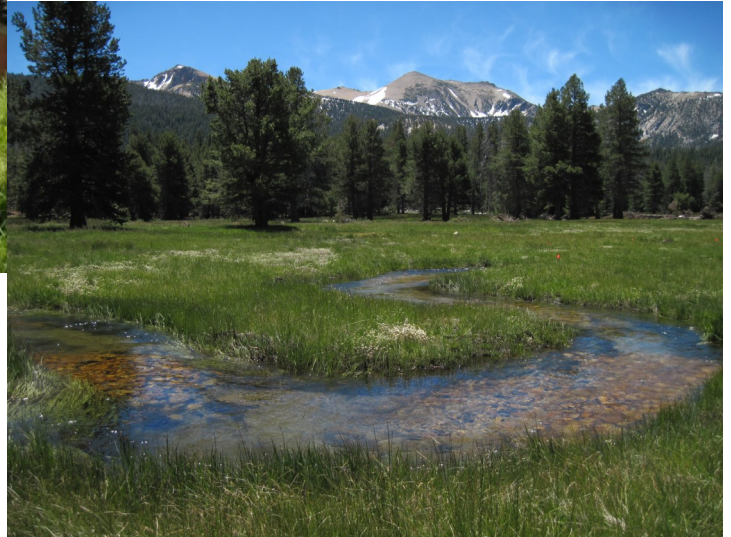
The photos below illustrate the “greening” that has occurred in both of these meadows adjacent to the restored reaches, as meadow grasses have responded quickly to the increased extent and duration of plant available water.

*Cookhouse Meadow, 2011  
(left) and High Meadows,  
2013 (below)*

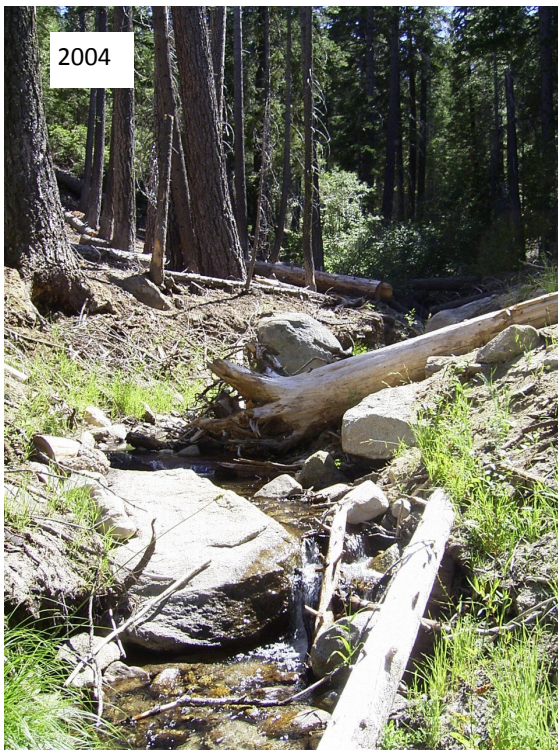
***Lonely Gulch, post project***

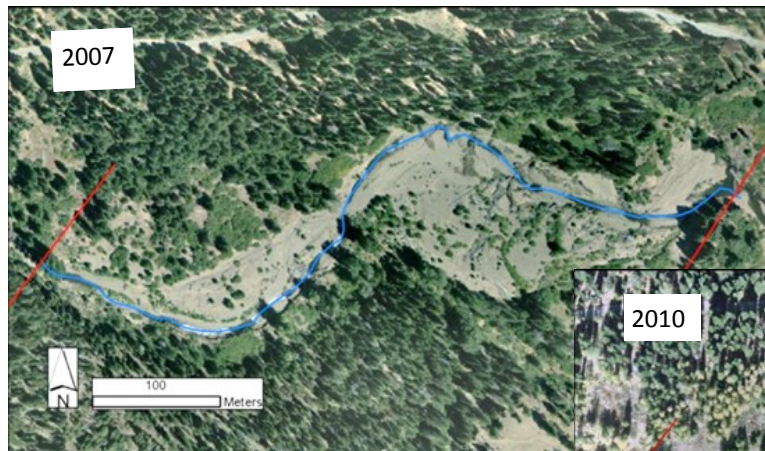
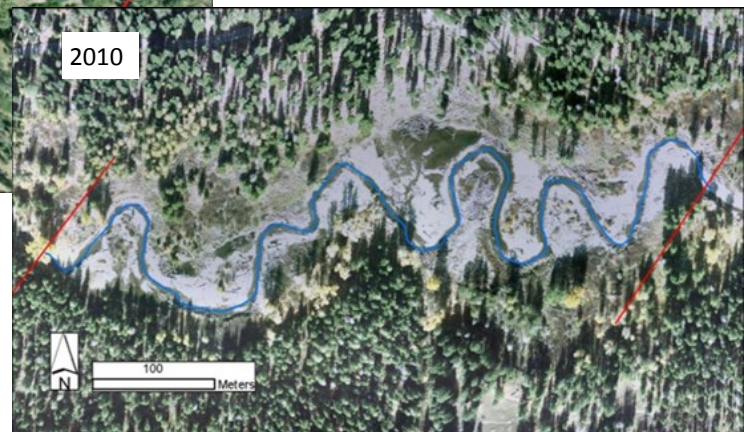
As a result of restoration of 1.3 miles of stream channel, the degraded reaches of Blackwood creek are no longer dominated by processes of channel erosion. Channel stability has been greatly improved, and floodplain connectivity and channel bar and floodplain development has been restored. Post-project measurements currently exceed the Blackwood TMDL targets for the two metrics of 1.6 sinuosity and 80% bank stability. The figures below illustrate the increase in channel sinuosity in one of the restored reaches (Reach 6) as a result of restoration.

***Increase in Blackwood creek sinuosity between 2007 and 2010.***

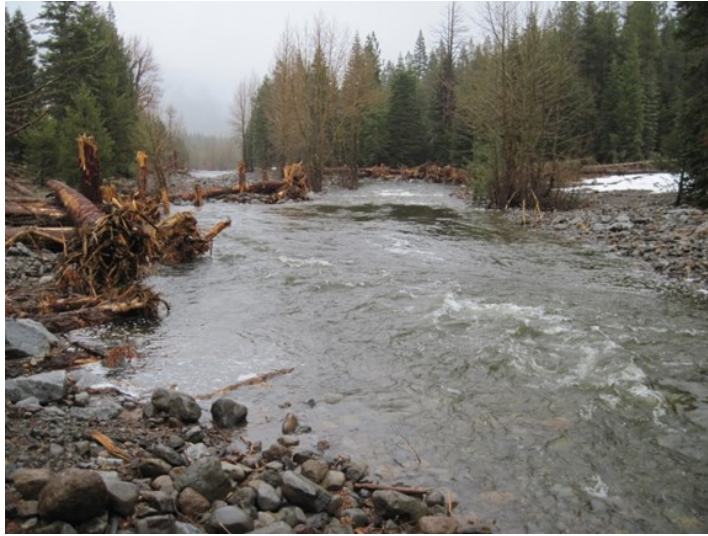
*December 3, 2012, rain on snow event, (two months after completion of the Blackwood Reach 1 project) estimated to be an 8 to 10 year frequency flow event (@800 cfs). Through bed load transport and deposition this event raised the base elevation of the stream channel closer to desired levels. Installed rock weirs in the stream bed and log stream bank stabilization structures were successful in maintaining channel form and stability during this event.*

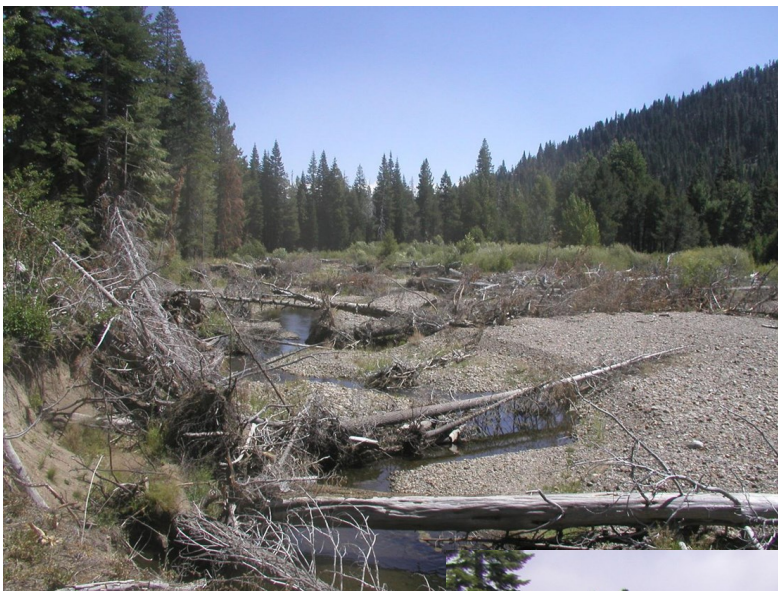
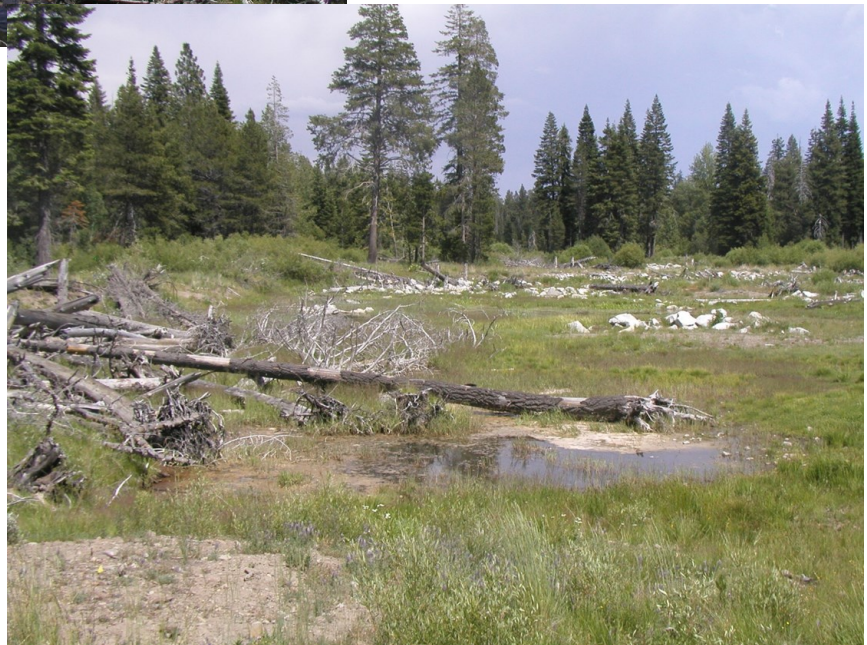
*Blackwood pre-project, 2006.*

*Blackwood post project, 2014. Channel has been moved to right (off of photo), and former channel location converted to inset floodplain. Although some riparian willow stakes were planted, much of observed revegetation is occurring through natural processes of flood plain deposition during overbank flooding.*

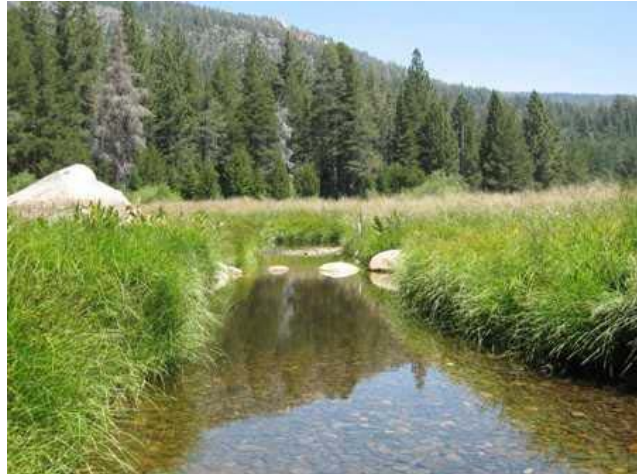
### ***Big Meadow Creek post project, 2008***

Replacement of Big Meadow creek channel with a new channel in Cookhouse Meadow successfully converted the channel type from an highly incised channel experiencing accelerated bank erosion (Rosgen F, see photo on page 11) to a stable channel form (Rosgen C), illustrated in the photo to the left.\*

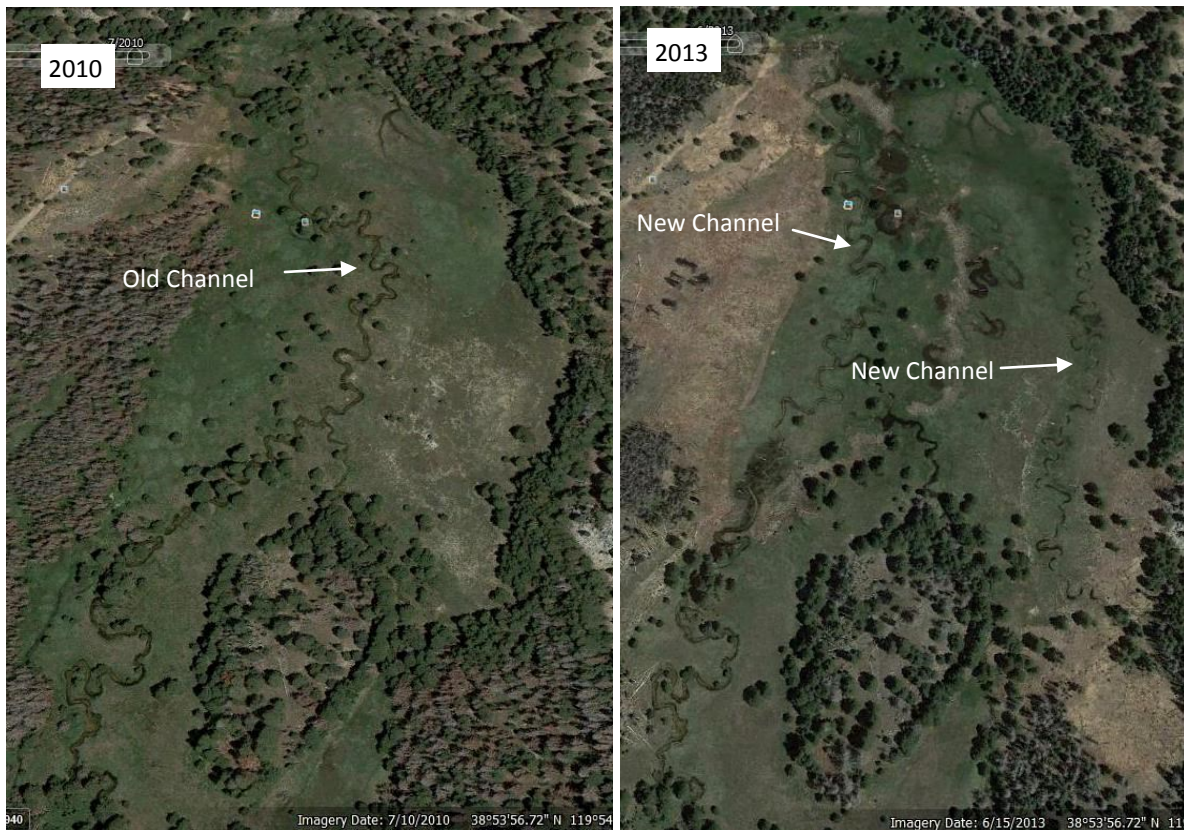
### **Change in channel location and length at Cold Creek**

Cold Creek in High Meadows demonstrates improved morphology in terms of width/depth ratios, pool riffle ratios, and stream bank stability, and has increased overall stream channel length from 2,500 feet to 3,600 feet. Notice also the large area of dead conifer removal in the left side of photos below.

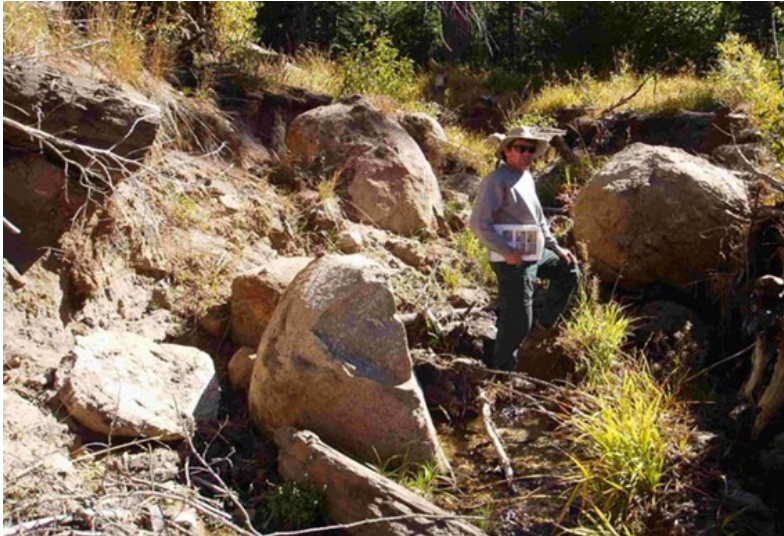
One of the projects discussed in the introduction, Marlette Dam restoration, is not yet exhibiting satisfactory success in terms of producing a dynamically stable channel. We believe the failure occurred in the design phase. Post project analysis determined that design specifications did not sufficiently size or key in large boulder stabilization structures, and the channel design did not specify appropriate sinuosity and channel gradient relative to valley slope. This reach is still being monitored, and recommendations for adaptive management may result if channel degradation continues.

***Marlette Creek, 2011. Post project channel incision/erosion resulting in channel down cutting and widening, in 200 feet of the restored channel. Installed large boulders no longer effective as a channel stability component.***

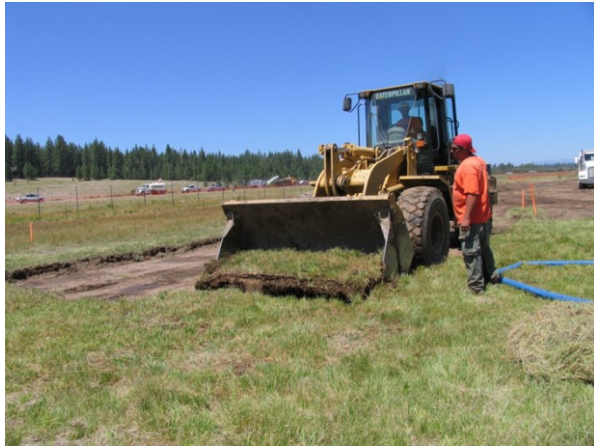
We have had great success in constructing almost immediately functional and stable channel banks in newly construction channels in meadow systems by harvesting sod on site as much as possible. This involves using a skilled equipment operator to “scalp” existing sod in the alignment of the new channel (as well as temporary roads), and carefully placing and stacking this material immediately on newly constructed channel banks. If sod needs to be stockpiled, prior to placement (such as when rebuilding floodplains) it should be routinely irrigated and watered. The constructed banks will need to be irrigated and allowed to “season”, before re-introducing flows. Typically a year of seasoning is adequate, but if the quality of harvested sod is high, you can get away with a couple of months of the growing season. If contracting, it is important to build flexibility in contracting specifications related to irrigation timing and performance specifications, to ensure the desired outcome is achieved. And finally we have also learned it is important to control the height of intercepted water in newly constructed channels during seasoning years, to not “drown” emerging bank vegetation. The photos on the next page illustrate successful sod harvesting techniques.

***Sod harvesting***

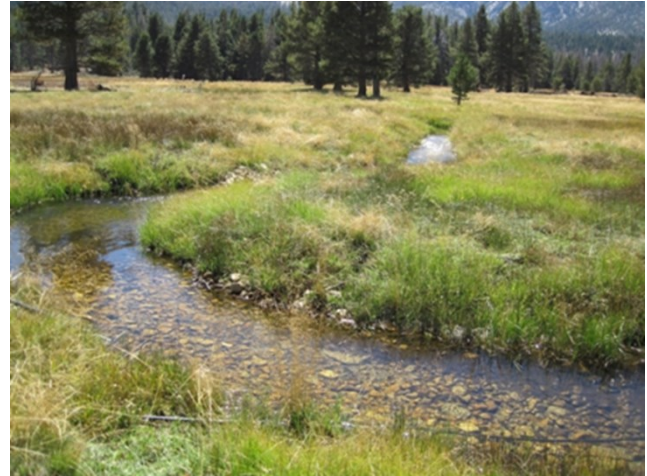
***Harvested sod channel banks on Cold Creek, two years after placement.***

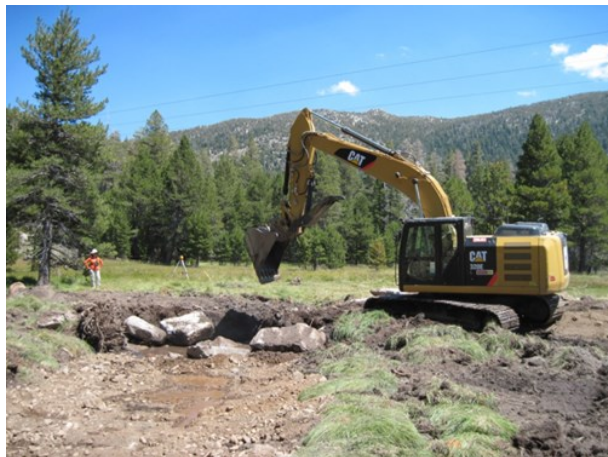
It cannot be over emphasized to not short cut the size and design of grade control structures. Materials must be of sufficient size, and keyed in deep into the channel and banks, so that they will not move as a result of future channel adjustments. In a properly designed grade control weir, you will not be able to see 80 % of the material in the weir after construction, the important “stuff”. In the photographs below, there is 6 feet of rock under the road to the right of the channel. And finally it is desirable to install grade control structure at natural valley constrictions or confined locations, particularly in meadow environments with fine grained soils.

***Grade control weirs, downstream end of Cold Creek channel restoration.***

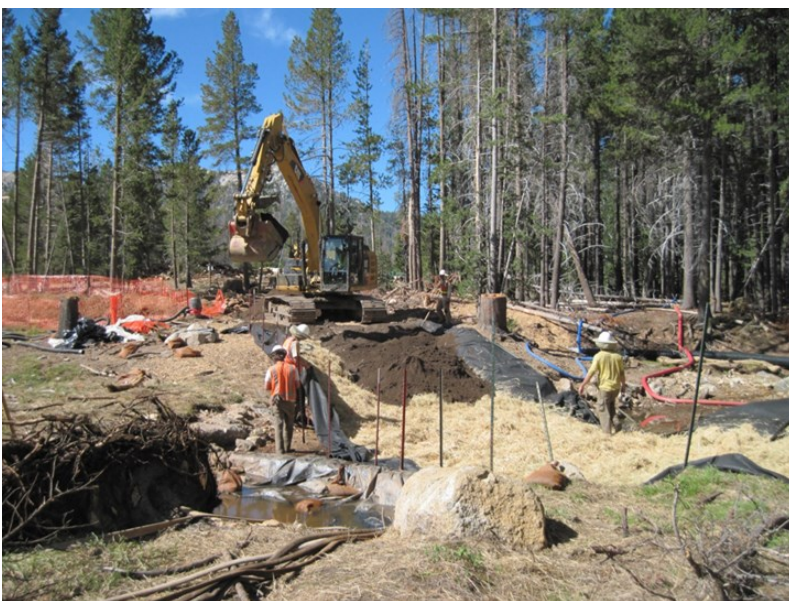
- At large crossings, with smooth, level channel substrate it can be effective to place the culvert into the channel first, and then sand bag flows into the culvert. If the channel substrate allows for effectively containing all flows into the culvert with sand bags, then road base material can be easily installed without resulting in turbid water releases.
- Place a 1 foot layer of straw between filter fabric and road base sediment. This creates a 3” compacted barrier to make it easier to remove the majority of road base fill when removing the stream crossing, without tearing the filter fabric.
- Use highest tensile strength fabric available, so that when you then pull up the fabric (and any remaining soil) no fine grained sediments escape into the stream channel bed.

***Stream crossing installation  
with straw layer.***

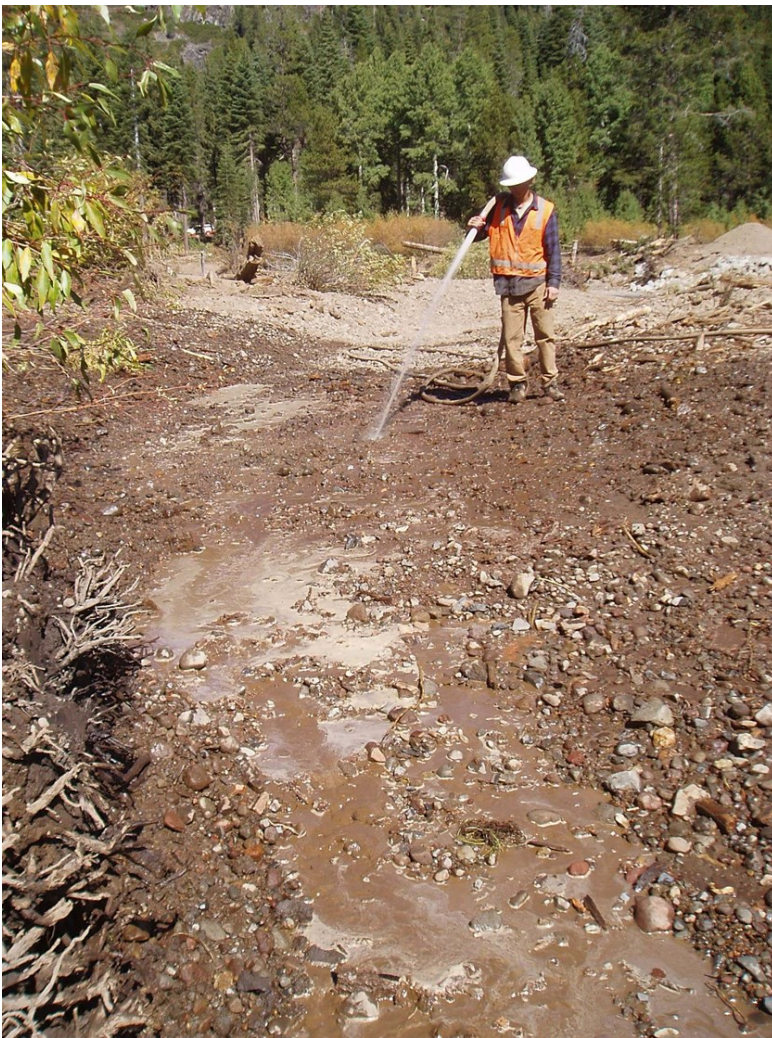
Jetting involves using a high pressure hose to spray the newly constructed channel surfaces, until turbid water is no longer visually evident (or for a maximum period of time) as negotiated with state regulatory agency.

***Jetting “dirty” substrate  
in Blackwood.***

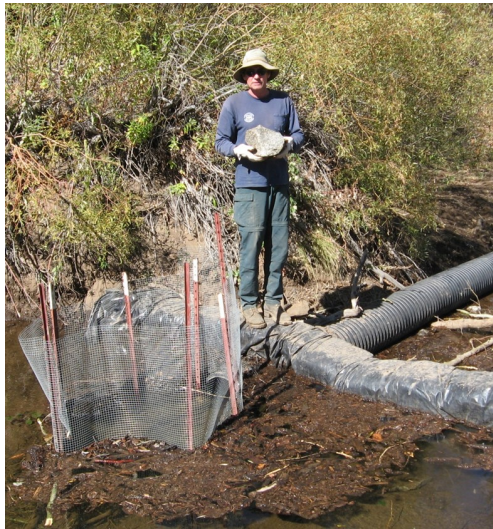
***Beaver boulder, removed from diversion***

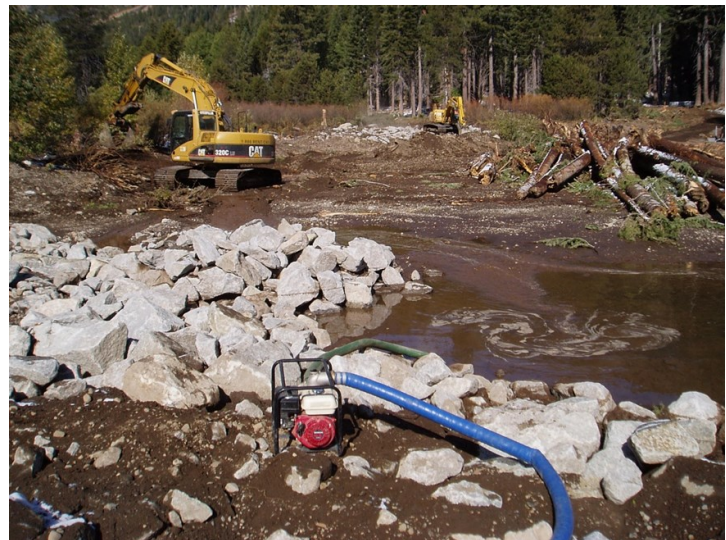
***Pumping turbid flows after rain event in Blackwood***

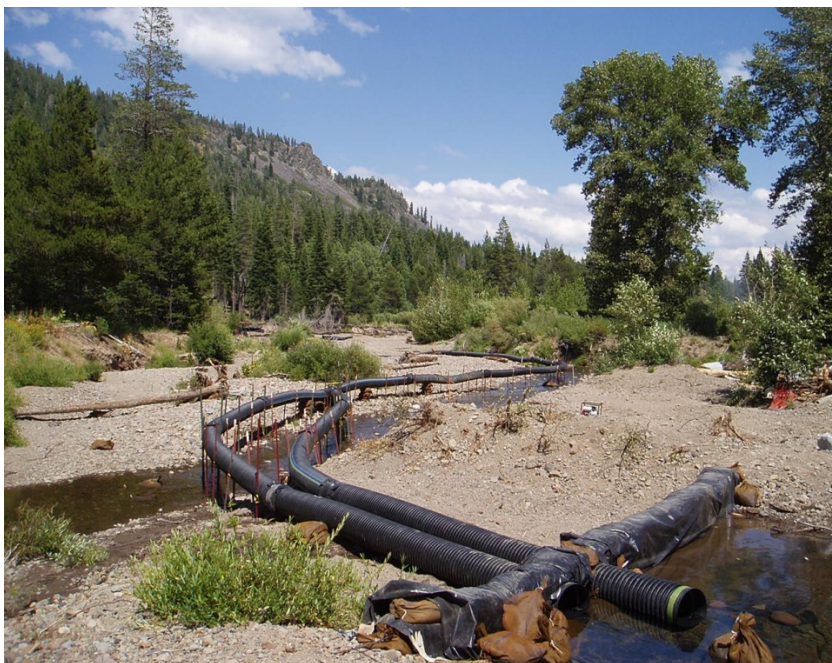
***LTBMU restoration crew ingenuity at its best, the Blackwood "Aqueduct" water diversion system.***
